ASIA TURBOMACHINERY & PUMP SYMPOSIUM
12 - 15 MARCH 2018
SUNTEC SINGAPORE

METALLURGICAL FAILURE ANALYSIS OF STEAM TURBINE, COMPRESSOR, AND HOT GAS EXPANDER COMPONENTS

David Dowson

Service Engineer (Materials & Repairs)
Elliott Group
Jeannette, PA, USA

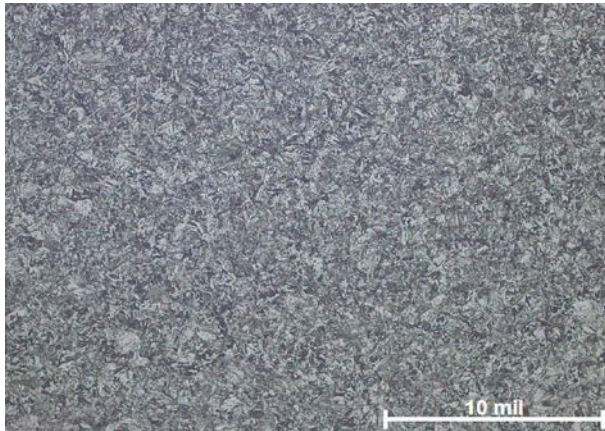
verify the material is in the correct heat treated condition. Figure 3 shows the correct quench and tempered condition of a steam turbine blade. The main purpose of these tests is to eliminate a material issue as the cause of failure.

Figure 3. Quenched and tempered microstructure of AISI 403 Steam turbine blade

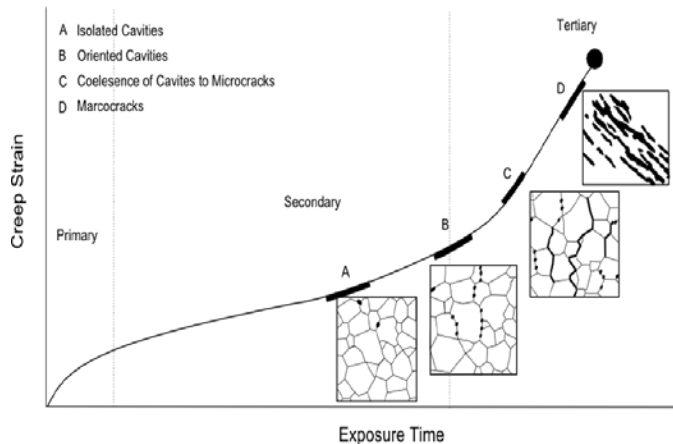
Figure 14. Stages of creep damage

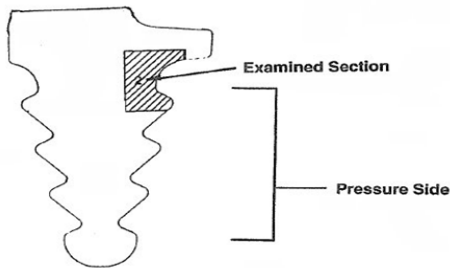
Several blades were cross-sectioned through the root to determine if the remaining blades exhibited the same Oxide/Sulfide attack as seen on the failed blade. The manner in which the blades were cross-sectioned is shown in Figure 29.

Figure 29. Area of blade cross sections
